Manhole Inspection Summary

Manhole # S53K__059MH

Insp Date: **7/29/08 1:46 PM**

Location Address: **703 east bouldin alley**

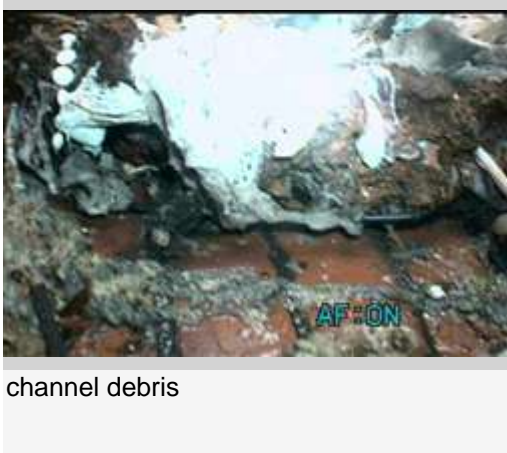
Defect 4

Condition: ☐ Sound ☐ Cracked ☐ Root Intrusion ☐ Deteriorated ☐ Leaks ☒ **Debris**

channel debris

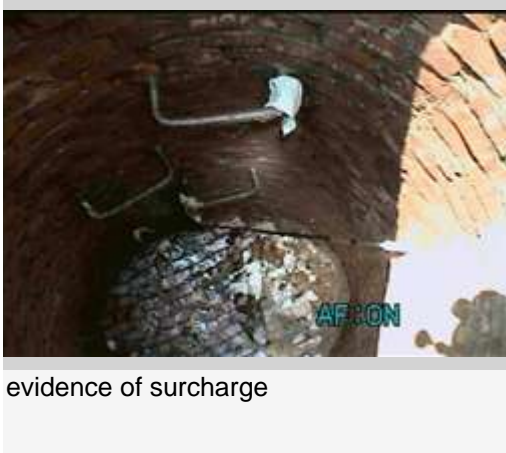
Defect 3

☒ **Evidence Of Surcharge** Depth: **7** (ft.) ☐ Active Surcharge Present

evidence of surcharge

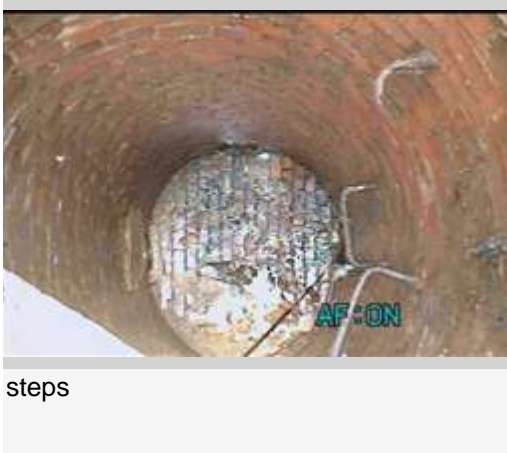
Defect 2

Count: **5** Missing: **1** ☒ **Corroded**

steps

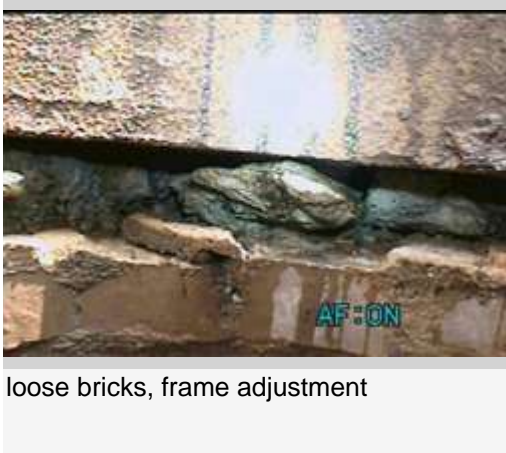
Defect 1

Condition: ☐ Sound ☐ Cracked ☐ Root Intrusion ☒ **Loose Brick** ☐ Deteriorated

loose bricks, frame adjustment

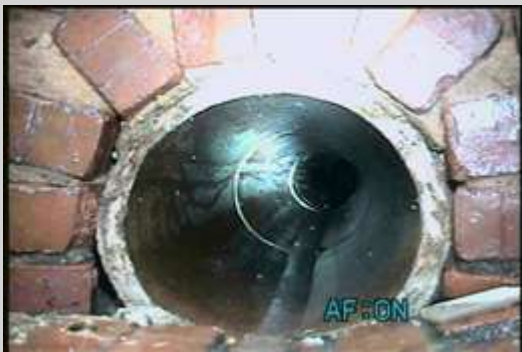
12 O'Clock Outflow

8 in. Circular Gravity Sewer
Pipe Out @ 12 O'Clock

Pipe Material: **Clay** ☐ Pipe Lined

Invert Depth: **10.16** (ft.) Flow Characteristics: **None**

Deposits: ☒ None ☐ Mud ☐ Sludge ☐ Debris ☐ Grease

Infiltration: **None** Pipe Seal Cond: **Unknown**

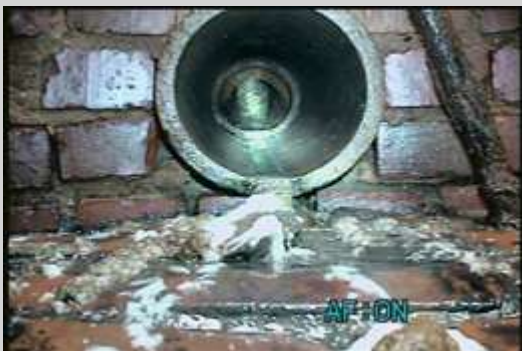
3 O'Clock Inflow

8 in. Circular Gravity Sewer
Pipe In @ 3 O'Clock

Pipe Material: **Clay** ☐ Pipe Lined

Invert Depth: **10.00** (ft.) Flow Characteristics: **None**

Deposits: ☒ None ☐ Mud ☐ Sludge ☐ Debris ☐ Grease

Infiltration: **None** Pipe Seal Cond: **Unknown**

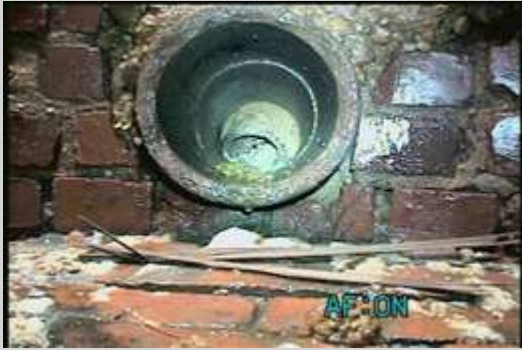
9 O'Clock Inflow

8 in. Circular Gravity Sewer
Pipe In @ 9 O'Clock

Pipe Material: Clay ☐ Pipe Lined

Invert Depth: 10.10 (ft.) Flow Characteristics: None

Deposits: ☒ None ☐ Mud ☐ Sludge ☐ Debris ☐ Grease

Infiltration: None
